**Flood Control Project Maintenance  
Levee Inspections**

**Fall 2013 Levee Maintenance Deficiency Summary Report**

**Reclamation District No. 2085 Kasson**

**Levee Inspection Report By Mile - Fall 2013**

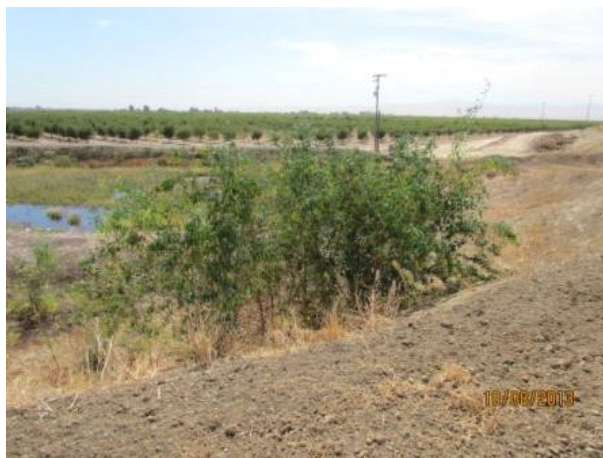
Levee Mile Report Line	4
Start Levee Mile	0.43
End Levee Mile	0.46
Location	Land Side
Category	Earthen Levee
Item	Vegetation

View of tall vegetation on landside slope obstructing visibility.

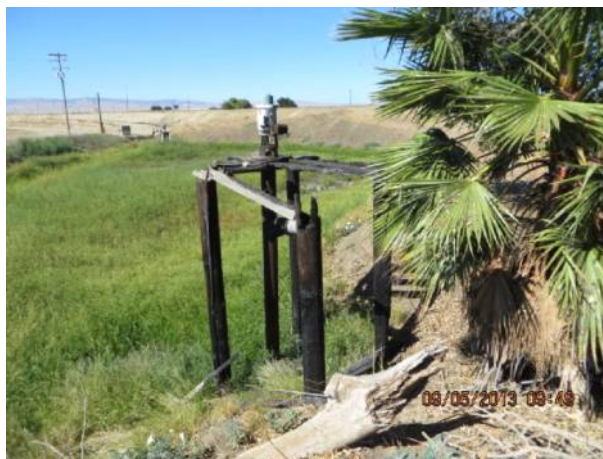
Levee Mile Report Line	5
Start Levee Mile	0.47
End Levee Mile	0.47
Location	Land Side
Category	Supplemental
Item	DWR UCIP Field Study

Pump on delapidated pier with no connection.

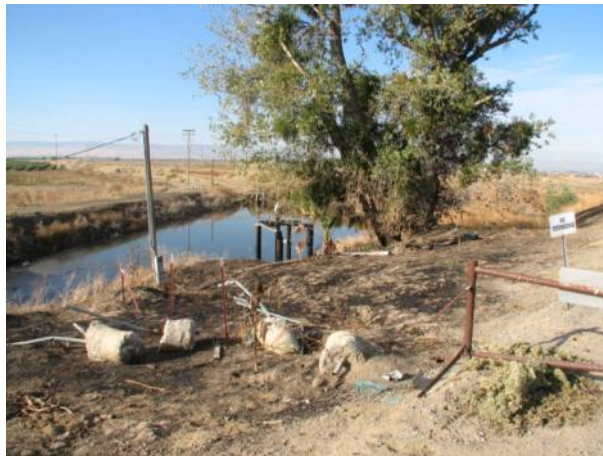
Levee Mile Report Line	6
Start Levee Mile	0.47
End Levee Mile	0.47
Location	Water Side
Category	Earthen Levee
Item	Encroachments

Drainage discharge pipe penetrates levee with no closure device.

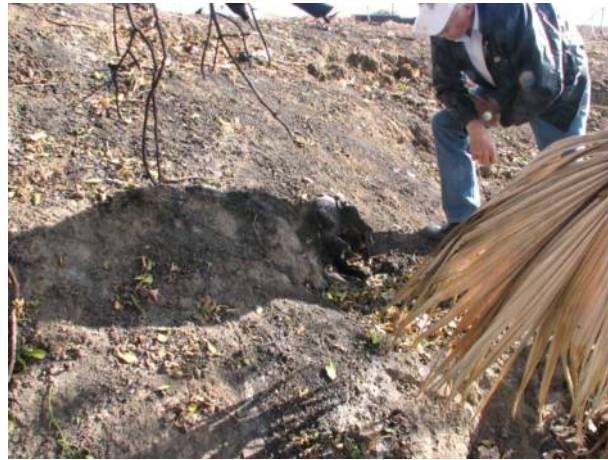
Levee Mile Report Line	6
Start Levee Mile	0.47
End Levee Mile	0.47
Location	Water Side
Category	Earthen Levee
Item	Encroachments

Opening on landside appears to consist of melted poly pipe halfway up levee slope. Opening on waterside is heavily corroded steel pipe.

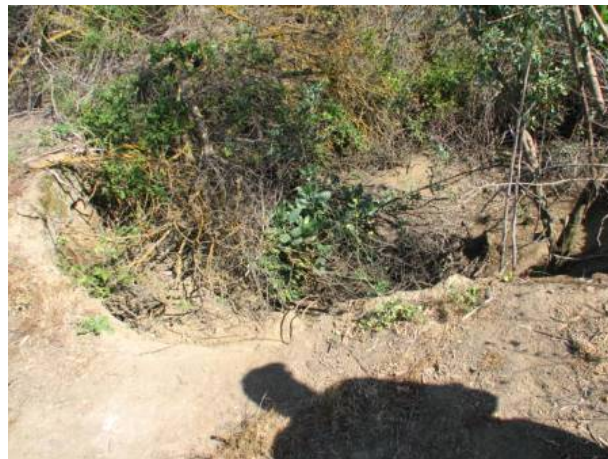
Levee Mile Report Line	6
Start Levee Mile	0.47
End Levee Mile	0.47
Location	Water Side
Category	Earthen Levee
Item	Encroachments

04/28/2011 Area around discharge pipe appears to be in an area of erosion. Area was found after weeds were cleared.

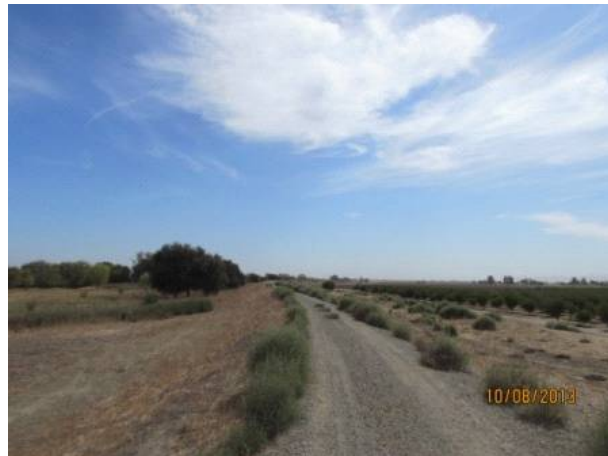
Levee Mile Report Line	7
Start Levee Mile	0.70
End Levee Mile	0.79
Location	Crown
Category	Earthen Levee
Item	Vegetation

View of tall vegetation along levee crown obstructing visibility.

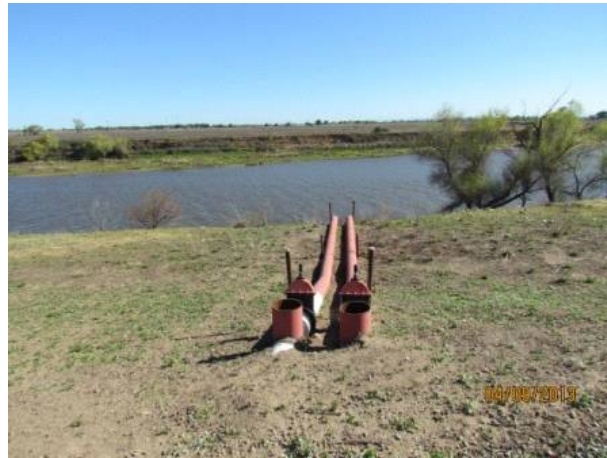
Levee Mile Report Line	12
Start Levee Mile	1.29
End Levee Mile	1.29
Location	Water Side
Category	Earthen Levee
Item	Encroachments

View of the pipe penetrating the waterside levee slope.

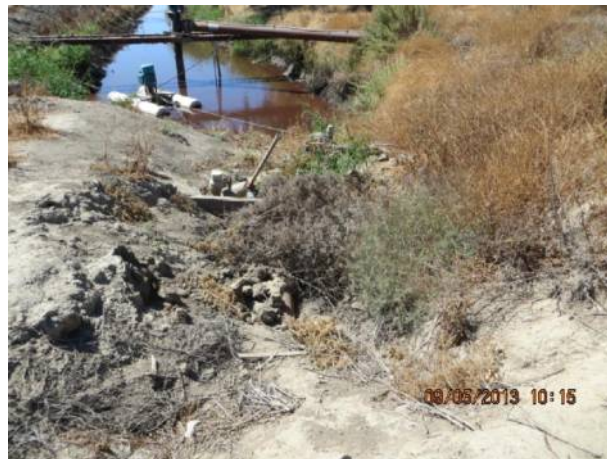
Levee Mile Report Line	13
Start Levee Mile	1.35
End Levee Mile	1.35
Location	Water Side
Category	Supplemental
Item	DWR UCIP Field Study

Pipe visible at bottom of ditch on LS toe.

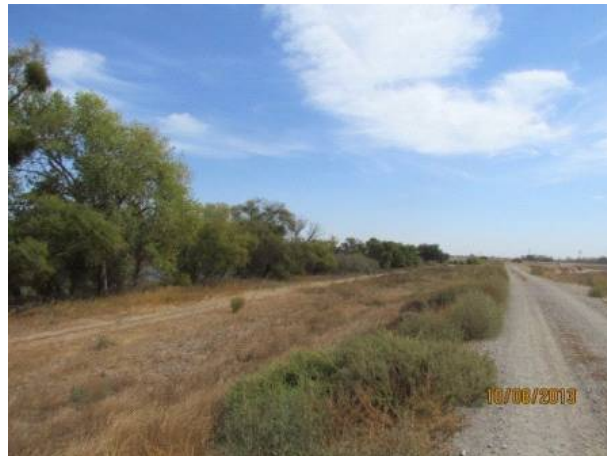
Levee Mile Report Line	14
Start Levee Mile	1.68
End Levee Mile	1.82
Location	Water Side
Category	Earthen Levee
Item	Vegetation

DWR ID: DWR_RD2085_01_f_2013_13										
14	1.68	1.82	Earthen Levee	Vegetation	WS	M Ma	V1 : Control annual grass and weeds on the levee slopes and easements.	37.711917 ° -121.283089 °	37.710483 ° -121.281030 °	8 Y
DWR ID: DWR_RD2085_01_f_2013_8										
15	1.98	1.98	Supplemental	DWR UCIP Field Study	WS	M En	Inspector Comments: FS_ID:19423 EP_NO: N/A Repair Type: Non-Urgent Crossing Status: Found UCIP Comments: This pipe is abandoned and should be done so properly. FIELD_STRUCT_DESC: 1 of 2: 10-inch pipe through the levee 2.0-feet below the crown. Pump mounted on pile structure in the river. Siphon breaker in 24-inch CMP riser on the LS slope. Power pole on LS toe. Wooden stairs and walkway from the berm to the pump structure. Originally included in the 1968 O&M manual. FS Date: 9/5/2013 8:22:24 AM	37.708826 ° -121.279271 °	37.708826 ° -121.279271 °	26 Y
DWR ID: DWR_RD2085_01_f_2013_26

View of tall vegetation on waterside slope obstructing visibility.

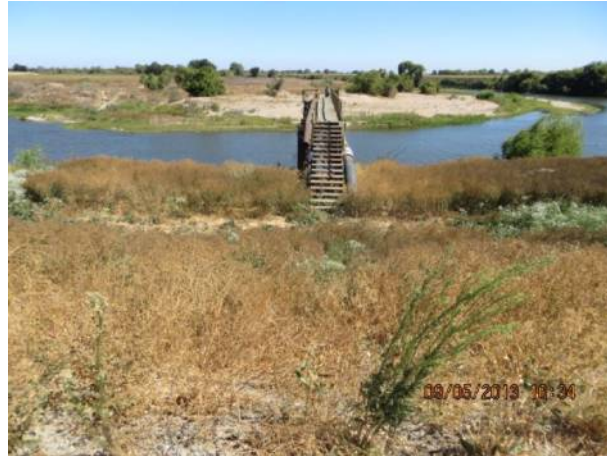
Levee Mile Report Line	15
Start Levee Mile	1.98
End Levee Mile	1.98
Location	Water Side
Category	Supplemental
Item	DWR UCIP Field Study
Pipe cut at wooden pier. No pump on end of pier for this pipe.	
UCIP_11736.jpg

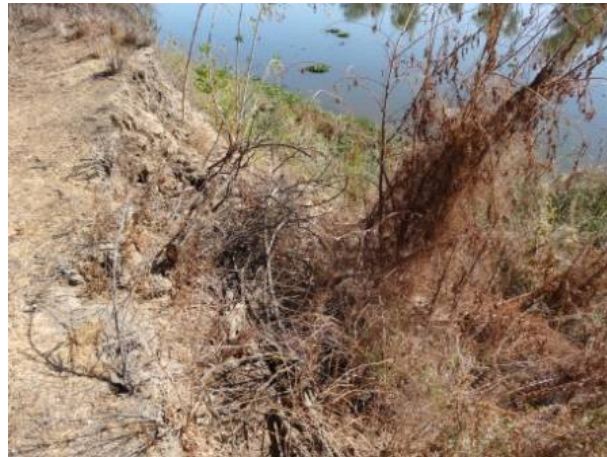
17	2.24	2.26	Supplemental	DWR Erosion Survey	WS Ma	Inspector Comments: 09/20/2013: No significant change observed. 12/04/2012: The erosion has progressed remarkably toward levee, extended to the up-and downstream of the original pocket erosion. Trees and dense bush are present at the site. Animal burrow holes are visible, and possibly can cause seepage. 09/22/2010: No significant changes observed. There is little visibility due to seasonal grass on the berm and slope. 08/18/2009: Site is located on berm; pocket erosion has developed; the site is covered in dense vegetation; there are several relief wells on the landside of the levee; site is Not Rated because berm width is greater than 30 feet; site should be monitored to keep track of erosion progress. [2013 Site ID:RD2085U01RM66.5]	37.703094 ° 121.274894 °	37.703094 ° 121.274894 °	31 Y
----	------	------	--------------	--------------------	----------	--	-----------------------------	-----------------------------	---------

Levee Mile Report Line	17
Start Levee Mile	2.24
End Levee Mile	2.26
Location	Water Side
Category	Supplemental
Item	DWR Erosion Survey
Close view of the erosion.	
SJR2013_RD2085U01RM66.5_2.jpg

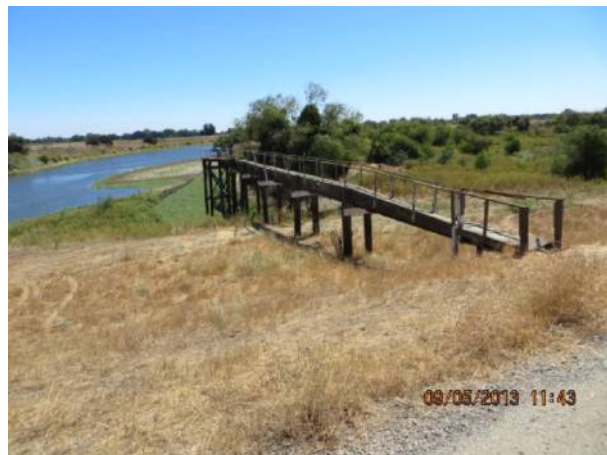
19	2.75	2.75	Supplemental	DWR UCIP Field Study	LS En	Inspector Comments: FS_ID:19431 EP_NO: 16970 Repair Type: Non-Urgent Crossing Status: Found UCIP Comments: The wooden walkway on the WS slope is in disrepair. FIELD_STRUCT_DESC: 1 of 2: 14-inch steel irrigation pipe through the levee 2.0 feet below the crown. Pump on wooden pier at WS slope. Siphon breaker visible next to steel bollard on LS slope. Power pole on LS toe. FS Date: 9/5/2013	37.699698 ° -121.276325 °	37.699698 ° -121.276325 °	27 Y
----	------	------	--------------	----------------------	----------	--	------------------------------	------------------------------	---------

Levee Mile Report Line	19
Start Levee Mile	2.75
End Levee Mile	2.75
Location	Water Side
Category	Supplemental
Item	DWR UCIP Field Study
Pump on Wooden pier at WS slopoe.	
UCIP_11740.jpg

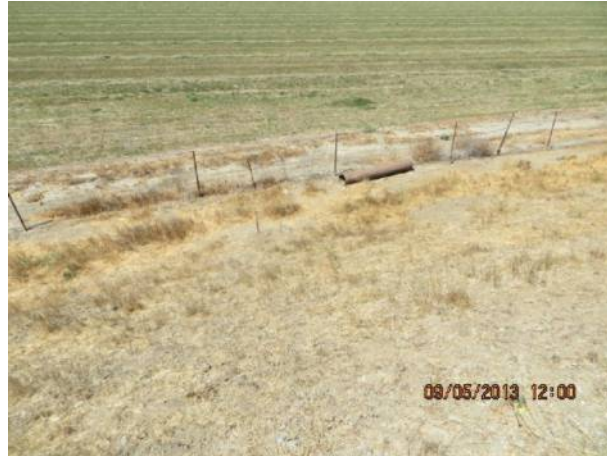
Levee Mile Report Line	20
Start Levee Mile	3.23
End Levee Mile	3.23
Location	Water Side
Category	Supplemental
Item	DWR UCIP Field Study

20	3.23	3.23	Supplemental	DWR UCIP Field Study	LS En	Inspector Comments: FS_ID:19432 EP_NO: N/A Repair Type: Non-Urgent Crossing Status: Found UCIP Comments: Pipe appears abandoned and should be done so properly. FIELD_STRUCT_DESC: 10-inch steel stormdrain pipe through the levee 4.0-feet below the crown. T-post marks location of Pipe at LS toe. Steel plate welded over pipe on WS slope. Asbuilts available DWG 7-4-1685. Originally included in the 1968 O&M manual. FS Date: 9/5/2013	37.693627 ° -121.277608 °	37.693627 ° -121.277608 °	28 Y
----	------	------	--------------	----------------------	----------	--	------------------------------	------------------------------	---------

T-post marking pipe end on LS toe. 10-inch pipe debris on LS toe.

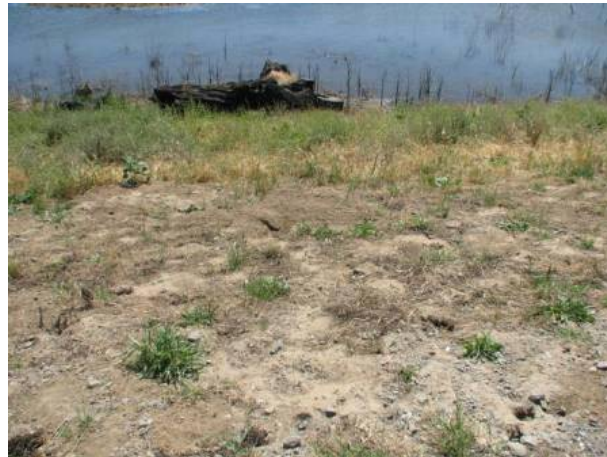
Levee Mile Report Line	22
Start Levee Mile	3.28
End Levee Mile	3.28
Location	Water Side
Category	Earthen Levee
Item	Animal Control

04/28/2011 Fresh burrow in center of picture, "porch" extends to the grass line.

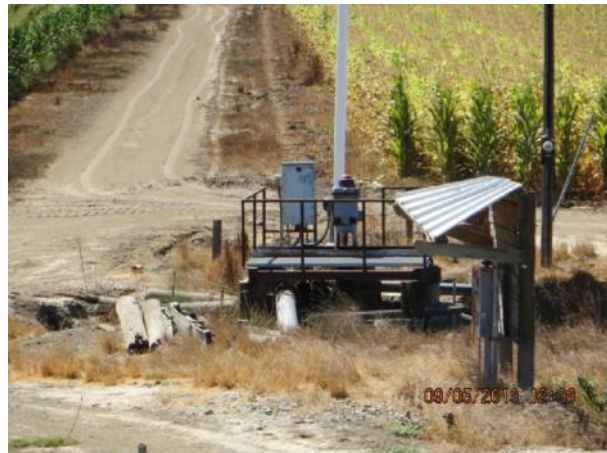
Levee Mile Report Line	24
Start Levee Mile	3.34
End Levee Mile	3.34
Location	Water Side
Category	Supplemental
Item	DWR UCIP Field Study

Possible connection at pump 150-feet off LS toe.

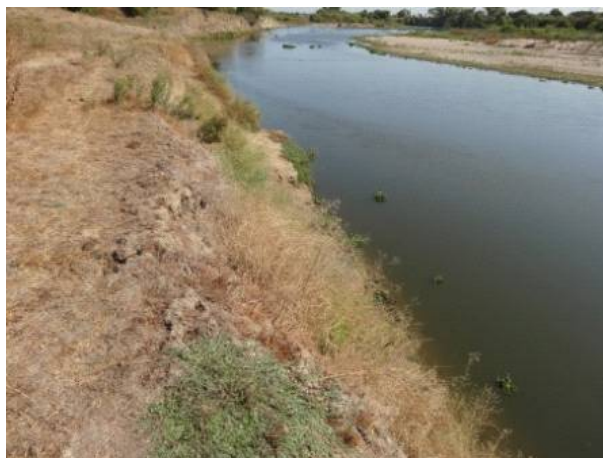
Levee Mile Report Line	28
Start Levee Mile	3.58
End Levee Mile	3.71
Location	Water Side
Category	Supplemental
Item	DWR Erosion Survey

Close view of the erosion.

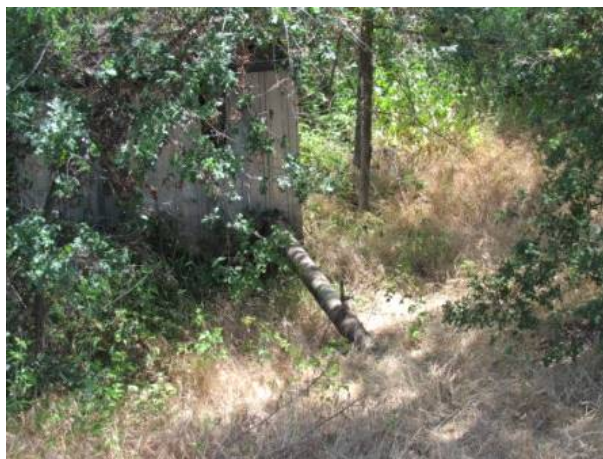
Levee Mile Report Line	30
Start Levee Mile	3.95
End Levee Mile	3.95
Location	Crown
Category	Earthen Levee
Item	Encroachments

View of pipe penetrating waterside slope.  
05/16/2012

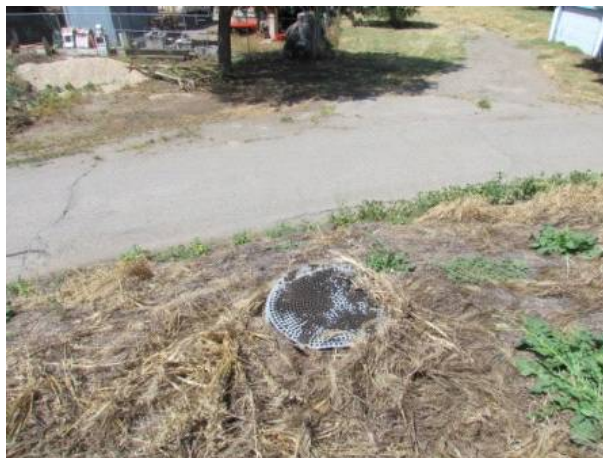
Levee Mile Report Line	30
Start Levee Mile	3.95
End Levee Mile	3.95
Location	Crown
Category	Earthen Levee
Item	Encroachments

View of siphon breaker valve on landside hinge.  
05/16/2012

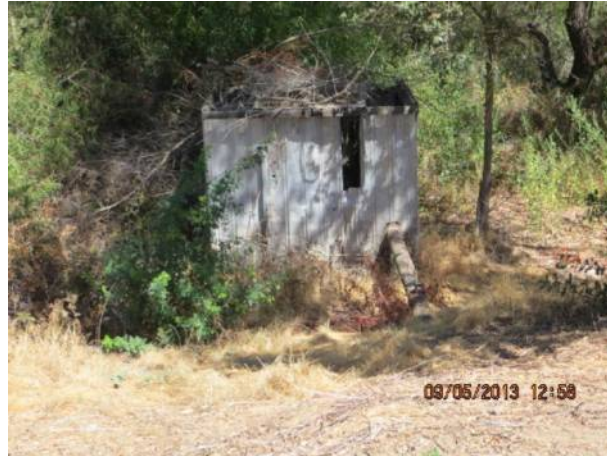
Pumphouse and pipe visible on WS toe.

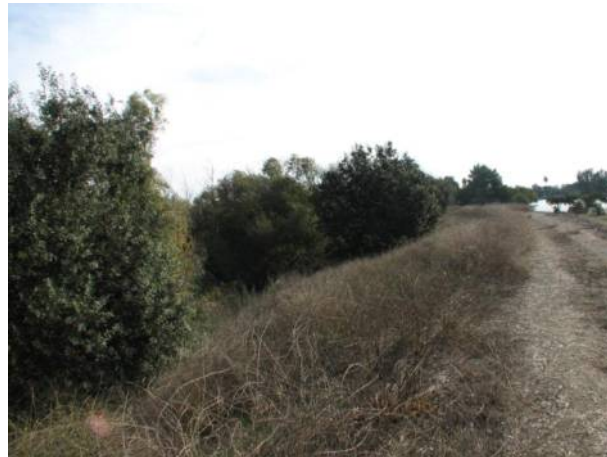
Levee Mile Report Line	33
Start Levee Mile	4.18
End Levee Mile	4.45
Location	Water Side
Category	Earthen Levee
Item	Vegetation

11/03/2011 Waterside vegetation needs to be maintained on the top 20' of the waterside slope.

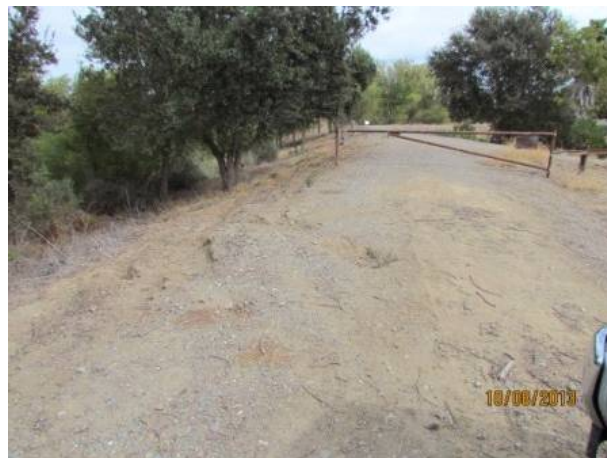
Levee Mile Report Line	34
Start Levee Mile	4.28
End Levee Mile	4.28
Location	Crown
Category	Earthen Levee
Item	Crown Surface / Depressions / Rutting

View of rutting on waterside levee slope and crown.

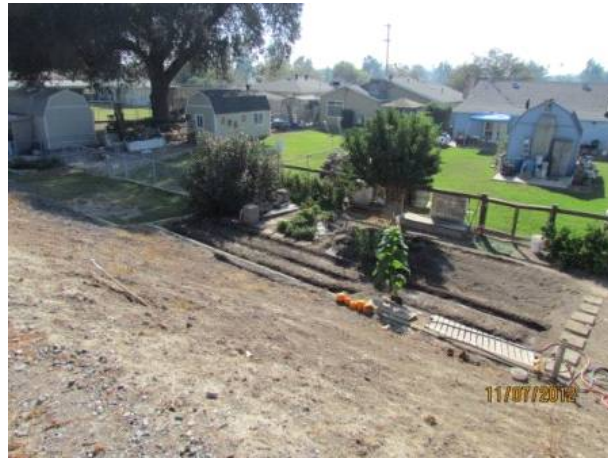
Updated photo of encroachments on landside toe.

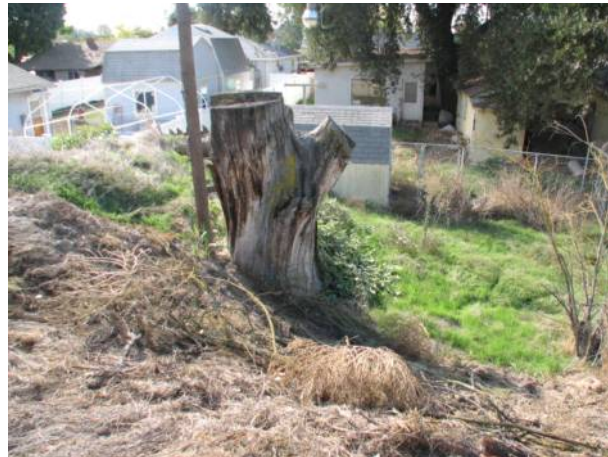
Levee Mile Report Line	36
Start Levee Mile	4.38
End Levee Mile	4.38
Location	Land Side
Category	Earthen Levee
Item	Trim / Thin Trees

11/03/2011 Large stump on landside slope.

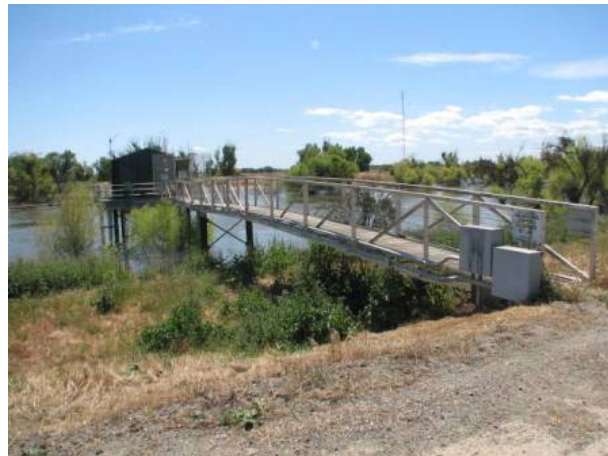
Levee Mile Report Line	39
Start Levee Mile	4.70
End Levee Mile	4.70
Location	Water Side
Category	Earthen Levee
Item	Encroachments

04/28/2011 Monitoring station.

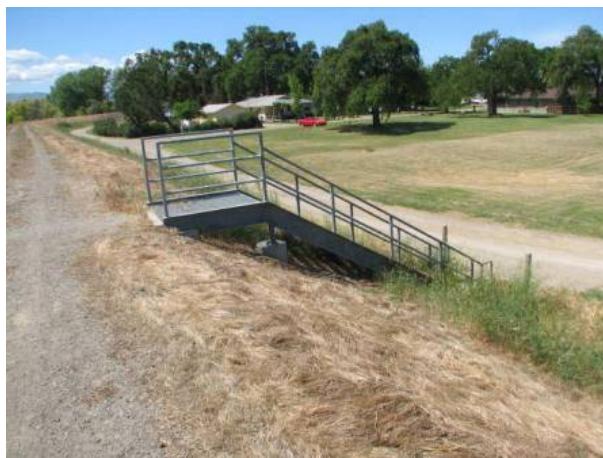
04/28/2011 Stairs on landside slope for monitoring station.

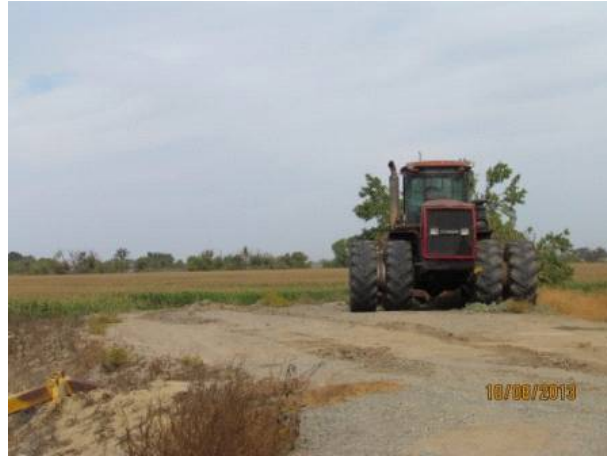
View of farming equipment being stored on the levee crown at the end of the spur levee.

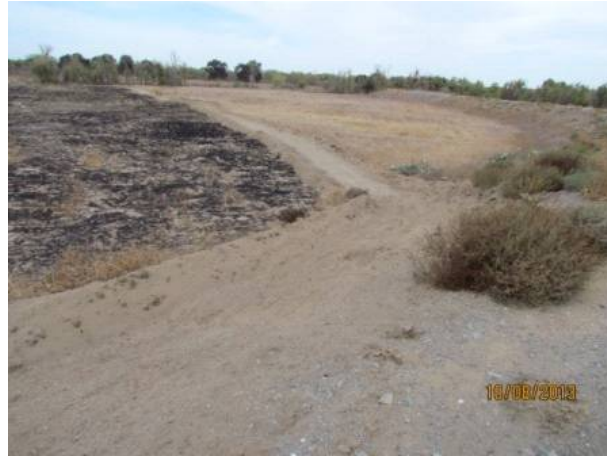
View of a cut on waterside levee slope.
